RE: Safety Recall #800-G
20-EDL Model Ball Sockets
Expiration Date: None

SUBJECT: SAFETY RECALL #800-G
20-EDL MODEL BALL SOCKETS
EXPIRATION DATE: NONE

EDL Socket Replacement (Tie Rods)

EDL Socket Replacement (Drag Links)

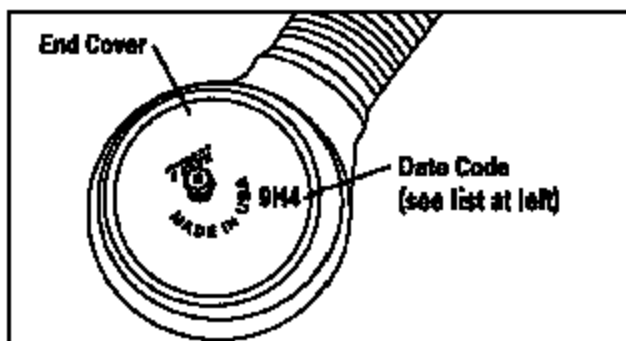
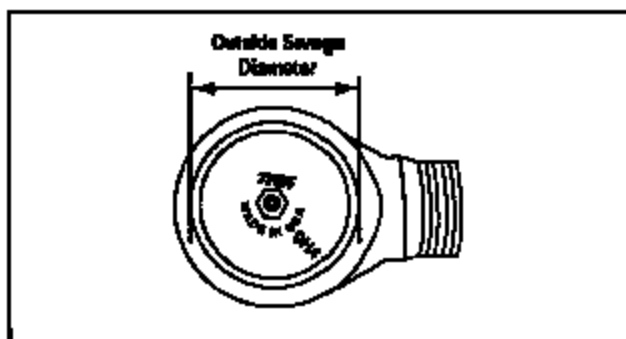
AND The sockets are "20 size" sockets. To identify the size: Measure the outside swage diameter. A 20 size socket will measure approx. 1 7/8". Any socket measuring 2 1/8" is a "24 size" socket, and is not part of the campaign.

NOTE: Only 20 size sockets are subject to this campaign. Make sure you are servicing the correct size socket.

NOTE: Any socket with "DL" stamped into the end cover is a different design, and IS NOT part of this campaign.

THEN Both socket ends need to be replaced using this kit.

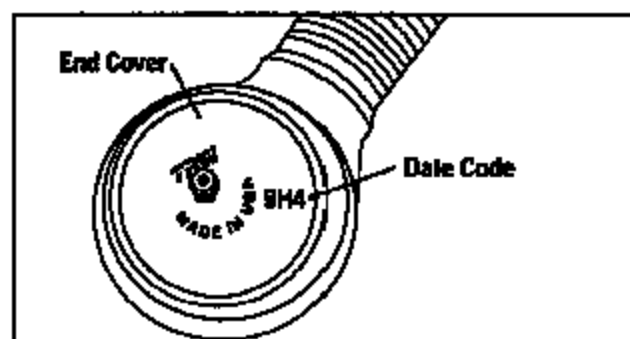
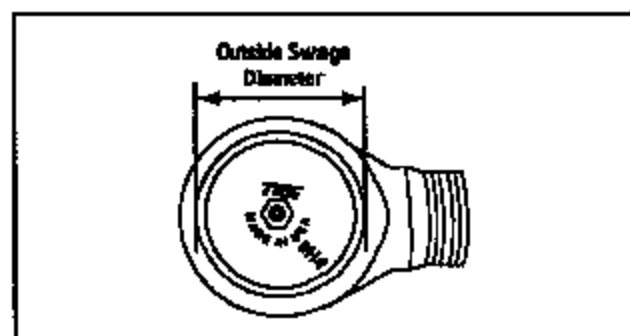
NOTE: Only 20 size sockets are subject to this campaign. Make sure you are servicing the correct size socket.

NOTE: Any socket with "DL" stamped into the end cover is a different design, and IS NOT part of this campaign.

THEN Both socket ends need to be replaced.

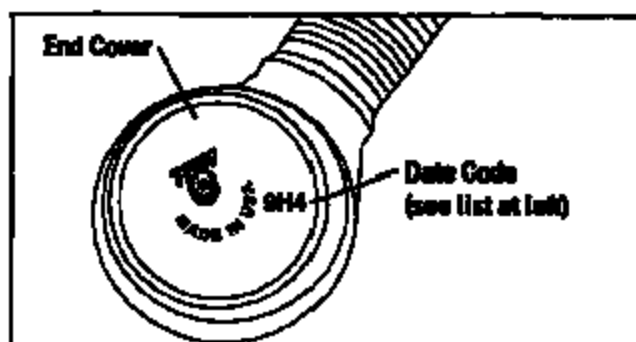
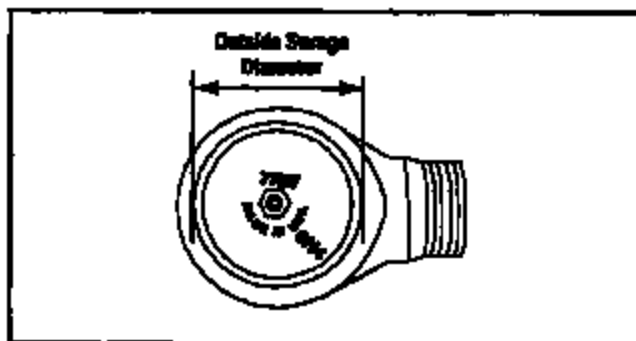
NOTE: Any socket with "DL" stamped into the end cover is a different design, and IS NOT part of this campaign.

NOTE: Only 20 size sockets are subject to this campaign. Make sure you are servicing the correct size socket.

THEN _____ Both socket ends need to be replaced using this kit.
